Manhole Inspection Summary

Manhole # S05AA2026MH

Location Address: **5934 CROSS COUNTRY BLVD** Cross Street: **SIMMONDS AVE**

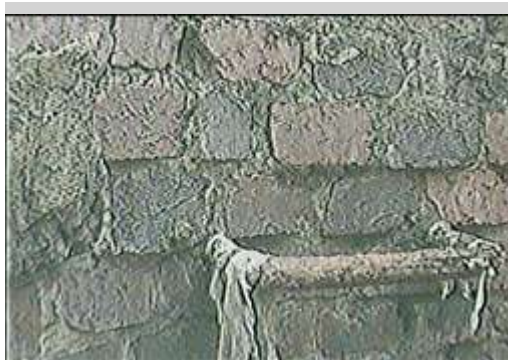
Evidence of surcharge - Bench debris.
Corroded steps.

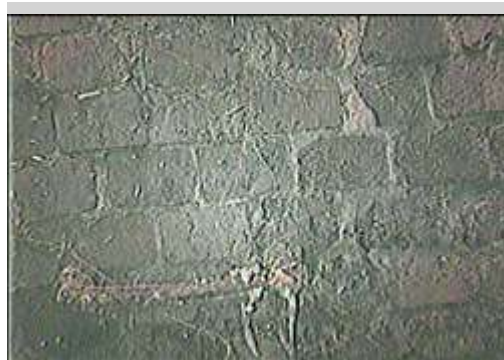
Defect

Corbel/Barrel root intrusion and
infiltration.

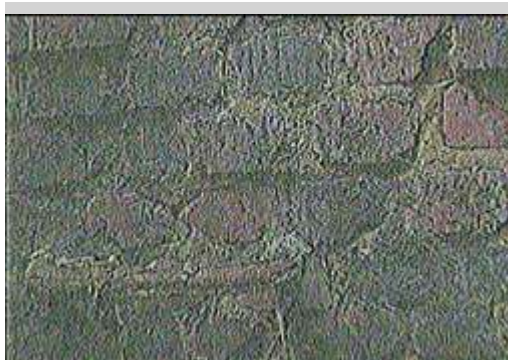
Defect

Corbel deterioration, root intrusion and
infiltration.

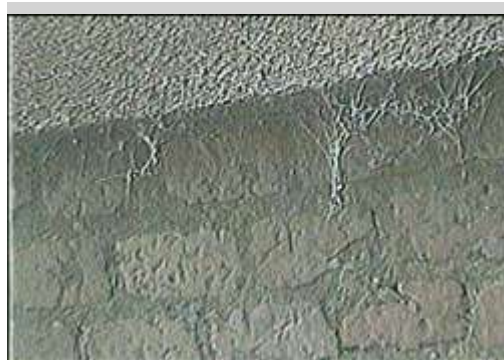
Defect

Frame leaks. Adjustment deterioration,
root intrusion and infiltration.

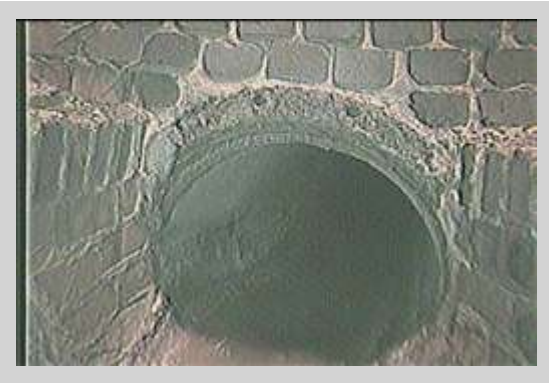
21 in. Circular Gravity Sewer Pipe Out @ 12 O'Clock

Infiltration: **Evidence** Pipe Seal Cond: **Cracked**

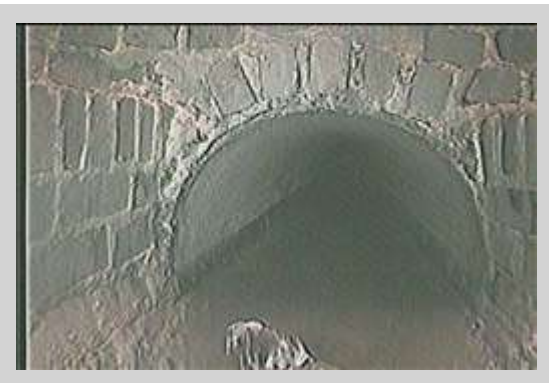
21 in. Circular Gravity Sewer Pipe In @ 6 O'Clock

Infiltration: **Evidence** Pipe Seal Cond: **Cracked**

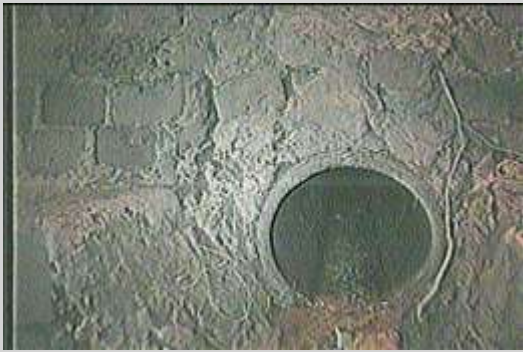
10 in. Circular Gravity Sewer

Barrel deterioration, root intrusion and infiltration. Channel root intrusion. Bench deterioration.

Infiltration: **Evidence** Pipe Seal Cond: **Roots**

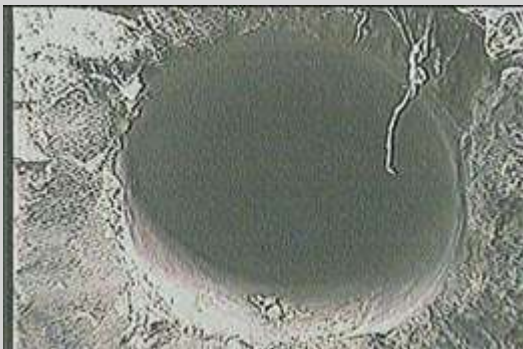
18 in. Circular Gravity Sewer

Infiltration: **Evidence** Pipe Seal Cond: **Roots**
